TUKWILA FACILITY ASSESSMENT

FACILITY ASSESSMENTS

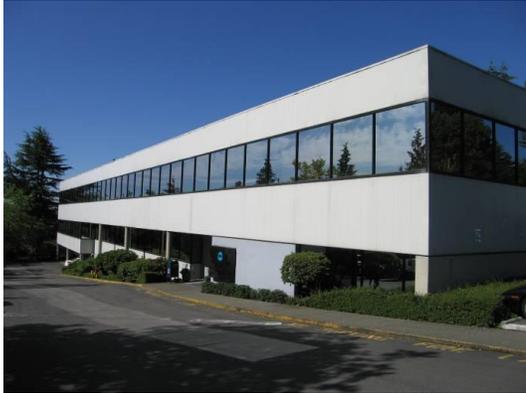
6300 BUILDING

The building was built to a low level of quality, both in the expense and quality of the materials used and the craftsmanship in the assembly. The basic structure of the building has suffered over the course of 36 years in operation. Foundation drainage is poor and floor topping slabs are cracked and in need of repairs. HVAC delivery is poor due to multiple space configurations over the course of the building's life.

The building quality is typical of a 30 year old office building. The building systems and construction materials are not that of a 50+ year lifespan institutional building. Examples are: Floor topping slabs are cracked and require replacement along with subfloor repairs and mechanical equipment has exceeded its expected lifespan and is due to be replaced. Exterior closure (roof and windows) are due for replacement. Lighting is original and inefficient. Heating, cooling, and ventilation air is poor due to multiple space re-configurations over the years.

The 2008 Reid Middleton report identified seismic deficiencies that would render it heavily damaged in a design-level earthquake. The ability to remain functional would be severely limited and the risk to inhabitants would be high.

The building requires significant replacement of building systems in order to extend the building lifespan. Lifecycle costs should be prepared and compared with building replacement costs. Building code review indicates the structure could be expanded, however site limitations and the condition/quality of the existing building render expansion a poor choice, unless the rest of the building is renovated to have an equal lifespan as a new addition.

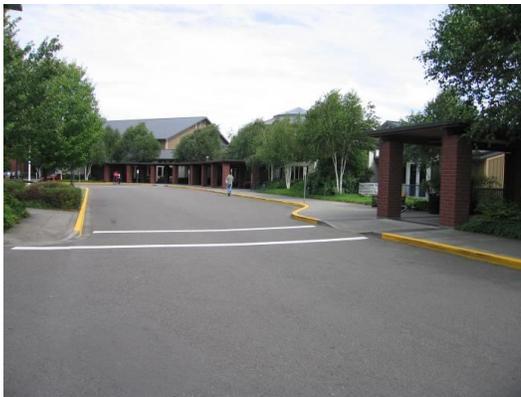
COMMUNITY CENTER

The building was built to a good-quality, commercial standard in 1995 and the interior is in good condition. However, time, weather, and poor flashing detailing have taken their toll on the exterior. We noted the following:

There are numerous signs of weathered paint and finishes as well as rotten trim and siding on all sides of the building. A lack of sheet metal window and trim flashings and failing caulking has also contributed to these conditions.

Water intrusion is noted at the interior of the windows where swelling of the mullions and interior trims is apparent.

Flashings and gutters incorrectly channel water behind eave trims and soffits, resulting in deterioration and damage to both.

Repainting and re-staining is required throughout the exterior of the building.

To preserve the building and prevent further deterioration, the Community Center should be evaluated by a weatherization consultant to determine appropriate fixes for the flashing issues. Priority should be given to these maintenance issues in order to prevent serious and expensive damage to the interior. An appropriately funded periodic maintenance program will allow this building to meet or exceed its expected lifespan.

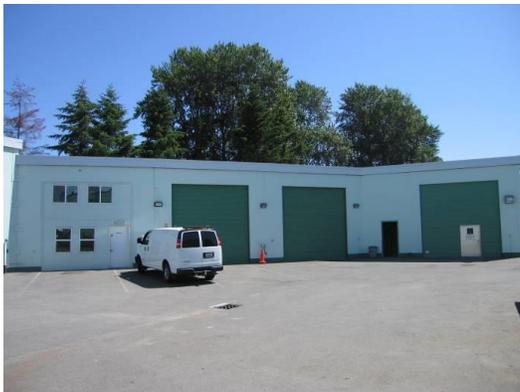
Minkler Shops Work Room and Storage Bin Building

Cracks are evident in the concrete wall panels at the storage bin portion of the Work Room and Storage Bin Building.

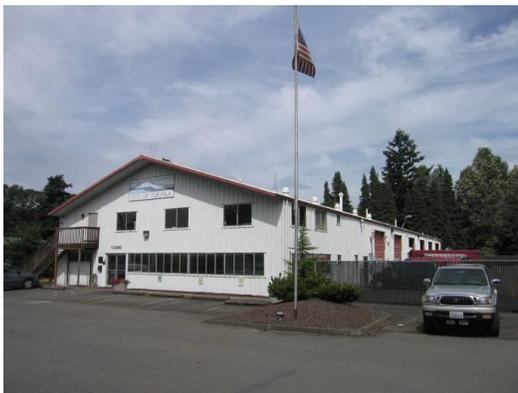
GEORGE LONG SHOP

The George Long Shops are in extremely poor condition. Many of the issues are related simply to the age of the facility as noted above.

Floor sump in maintenance bay is not operational and cannot be repaired; there is no means to control drainage of fluids on shop floor.

The shop floor slab has offsets of over one-inch, creating tripping hazards.

Seismic improvements would have minor architectural impacts to the spaces, but due to the costs of seismic retrofits, this building is recommended to be replaced. Should seismic improvements be elected, they can likely be performed without vacating the facility. However, even if all noted repairs, renovation, and seismic upgrades were performed, basic operational issues for large vehicle repairs would remain.
