Facility Evaluation Criteria

Facility Assessments

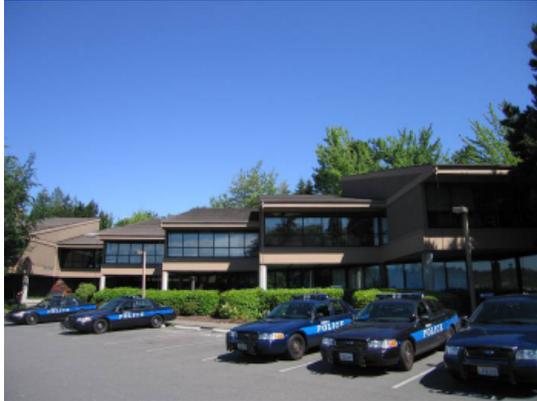
Deficiencies include insufficient cooling in areas with clerestory windows. The wall/ceiling/glazing insulating values are all well below current energy code standards, which contributes to an HVAC system that is heavily taxed. In addition to the HVAC system being dated and undersized, the general facility lighting is energy inefficient. The building's infrastructure and general condition exhibit the wear and tear, and condition expected for a building that is 37 years old. No major renovation work has occurred over that time. Consequently, many of the systems and finishes are nearing the end of their useful life. In 2008 The City of Tukwila identified \$ 4,125,000 worth of facility improvements needed for the City Hall building, not including seismic improvements.

Deficiencies are insufficient cooling in areas with clerestory windows, lack of privacy for confidential discussions, original floor-mounted "tombstone" power receptacles limit flexibility, no security at the Clerk's area open public counters, no access to replace/upgrade mechanical equipment, and lack of space for any further growth in staff. Storage space for records and in the vault is inadequate.

The 2008 Reid Middleton report identified multiple seismic deficiencies and noted the building as susceptible to unacceptable levels of damage and poor performance during a design-level earthquake. With that said, the structural condition of the building is generally satisfactory and reasonable measures to improve the building's seismic performance were proposed in their report.

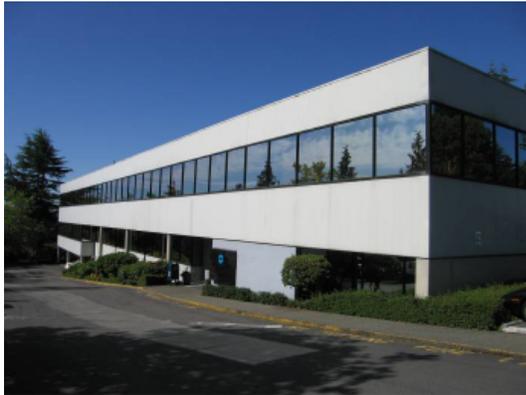
6300 Building

The building envelope (walls, roof, and windows) are well below current energy code standards, as determined by empirical observation and general experience with structures from this era. It has been identified that HVAC systems are dated and undersized, and the general facility lighting is energy inefficient. The building and its systems exhibit the wear and condition expected in a building that is 36 years old and has not had major renovation work during that time. In 2008, the City of Tukwila identified \$ 2,505,000 worth of facility improvements needed for the 6300 Building, not including seismic improvements.

The building was built to a low level of quality, both in the expense and quality of the materials used and the craftsmanship in the assembly. The basic structure of the building has suffered over the course of 36 years in operation. Foundation drainage is poor and floor topping slabs are cracked and in need of repairs. HVAC delivery is poor due to multiple space configurations over the course of the building's life.

Floor topping slabs are cracked and require replacement along with subfloor repairs and mechanical equipment has exceeded its expected lifespan and is due to be replaced. Exterior closure (roof and windows) are due for replacement. Lighting is original and inefficient. Heating, cooling, and ventilation air is poor due to multiple space re-configurations over the years.

The 2008 Reid Middleton report identified seismic deficiencies that would render it heavily damaged in a design- level earthquake. The ability to remain functional would be severely limited and the risk to inhabitants would be high.

The building requires significant replacement of building systems in order to extend the building lifespan. Lifecycle costs should be prepared and compared with building replacement costs. Building code review indicates the structure could be expanded, however site limitations and the condition/quality of the existing building render expansion a poor choice, unless the rest of the building is renovated to have an equal lifespan as a new addition.

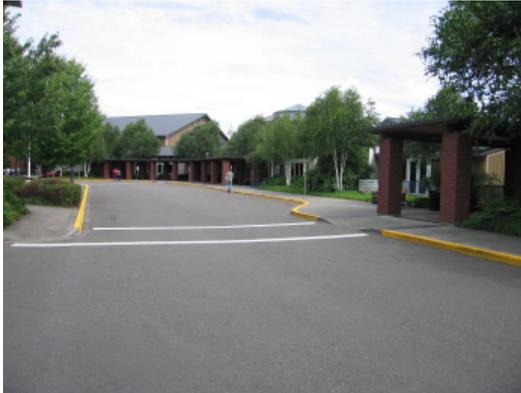
The building was built to a good-quality, commercial standard in 1995 and the interior is in good condition. However, time, weather, and poor flashing detailing have taken their toll on the exterior. We noted the following:

There are numerous signs of weathered paint and finishes as well as rotten trim and siding on all sides of the building. A lack of sheet metal window and trim flashings and failing caulking has also contributed to these conditions.

Water intrusion is noted at the interior of the windows where swelling of the mullions and interior trims is apparent.

Flashings and gutters incorrectly channel water behind eave trims and soffits, resulting in deterioration and damage to both.

The Community Center was not originally designed as an essential facility in terms of its usage as a potential emergency shelter. It therefore performs poorly when measured against the Immediate Occupancy seismic criteria. The site is also noted as susceptible to soils liquefaction and lateral spreading, contributing to its poor seismic capabilities.

Repainting and re-staining is required throughout the exterior of the building.

To preserve the building and prevent further deterioration, the Community Center should be evaluated by a weatherization consultant to determine appropriate fixes for the flashing issues. Priority should be given to these maintenance issues in order to prevent serious and expensive damage to the interior. An appropriately funded periodic maintenance program will allow this building to meet or exceed its expected lifespan.

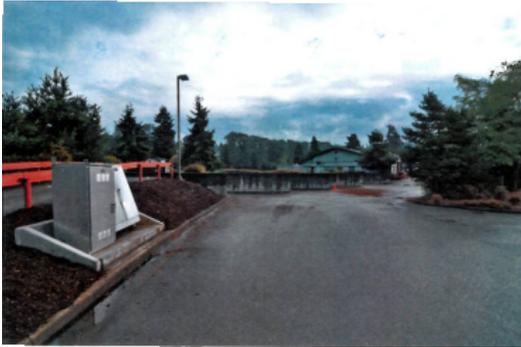
Parks & Golf Maintenance

The Parks and Golf Maintenance facility is generally in good condition and fulfills the role of supporting the city's maintenance crews. At 15 years of age, the building is showing signs of needing some exterior maintenance, but otherwise it is in reasonable condition.

Exterior Condition: The exterior of the facility is composed of fiber-cement panel siding with a concrete masonry veneer wainscot. Plywood soffits and cedar eave and rake boards are used at the roof. It is generally in good condition although the siding color has faded and the transparent-finished eaves and rakes are weathering poorly. New paint is recommended for all fiber-cement and wood surfaces. The asphalt composition roofing shingles are starting to show signs of wear and replacement of the roof is recommended within the next 5 to 7 years.

Interior Condition: The interior of the building is also in generally good condition for a building of its age and use. No major deficiencies beyond general wear and tear were observed.

Per Reid Middleton's 2014 report, the Parks and Golf Maintenance facility is generally in acceptable condition from a seismic, life-safety point of view. Due to its proximity to the Duwamish Waterway, soil liquefaction during a seismic event is a potential hazard. However, given the light loads from the structure and the slab-on-grade foundation system, the risk is low that the foundations will spread laterally and cause additional damage or structural instability.

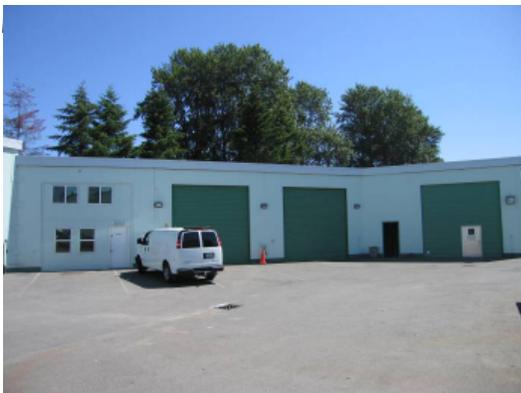
The Work Room and Storage Bin Building is a single-story, wood and concrete structure located in the southern commercial and industrial area of Tukwila. The 20-foot-tall building has an angular J-shape, with maximum plan dimensions of 90 feet by 130 feet and a cross-sectional width of 20 to 25 feet. Building construction consists of wood-framed and precast concrete roof structures supported by concrete shear walls.

Cracks are evident in the concrete wall panels at the storage bin portion of the Work Room and Storage Bin Building.

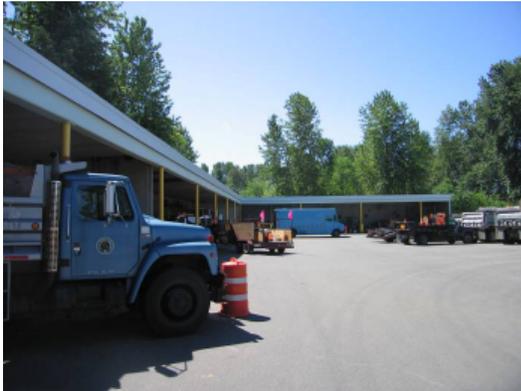
The Covered Parking is a partially open, single-story concrete structure located in the southern commercial and industrial area of Tukwila. The C-shaped structure has maximum plan dimensions of 140 feet by 300 feet and a cross-sectional width of 20 feet. Building construction consists of precast concrete roof planks supported by precast concrete walls and concrete beams on steel posts.

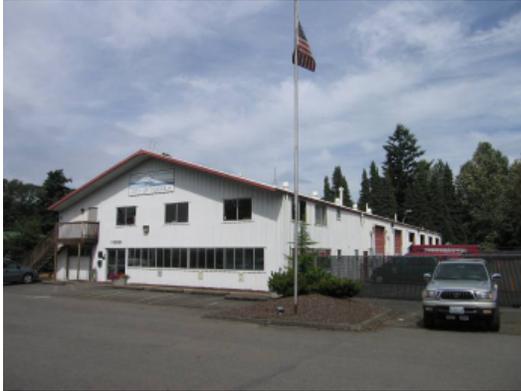
George Long Shop

The facility is lacking key functions needed to maintain city fleet operations that are required to restore essential city services following an emergency event. The building also lacks adequate facilities to maintain and repair larger vehicles severely limit the ability of this shop to perform its mission. No emergency power generator is present, making it impossible for this facility to meet its operational performance requirements during a power outage event.

Minimal insulation levels with no thermal breaks at the metal building envelope. Torn, damaged, or missing vapor barriers at numerous wall and roof insulation locations.

Uninsulated fiberglass overhead doors with holes due to age and UV deterioration.

The George Long Shops are in extremely poor condition. Many of the issues are related simply to the age of the facility as noted above.

Floor sump in maintenance bay is not operational and cannot be repaired; there is no means to control drainage of fluids on shop floor.

The shop floor slab has offsets of over one-inch, creating tripping hazards.

Seismic improvements would have minor architectural impacts to the spaces, but due to the costs of seismic retrofits, this building is recommended to be replaced. Should seismic improvements be elected, they can likely be performed without vacating the facility. However, even if all noted repairs, renovation, and seismic upgrades were performed, basic operational issues for large vehicle repairs would remain.

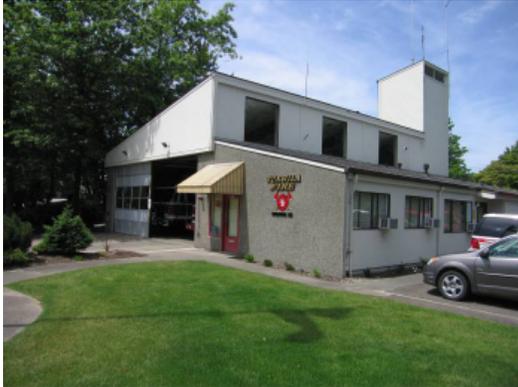
Fire Station 52

The station utilizes residential-grade, window-mounted air conditioners at the sleep rooms and day room. As such, they allow road noise from the street side of the building to transmit easily into the crew sleeping portions of the building.
