# 42<sup>nd</sup> Ave S Bridge Replacement Type, Size, & Location Report

Prepared for:  
City of Tukwila Public Works - Engineering  
April 2022

## **Executive Summary**

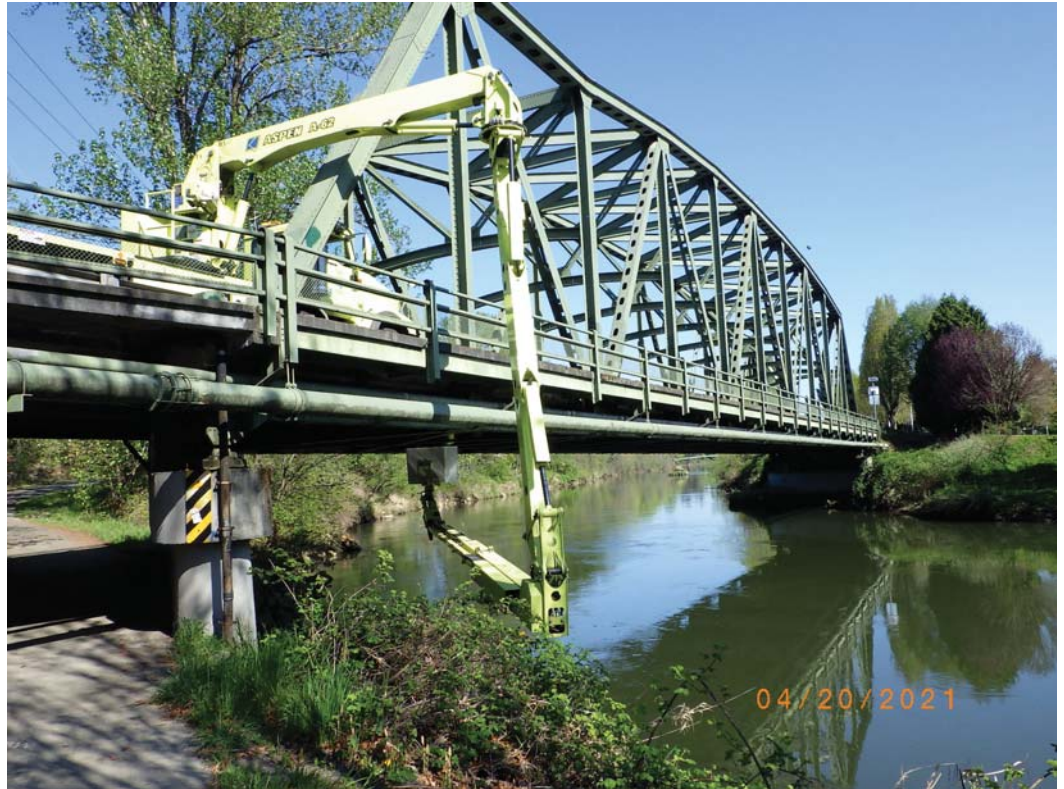
Remarks: East Elevation (Downstream)

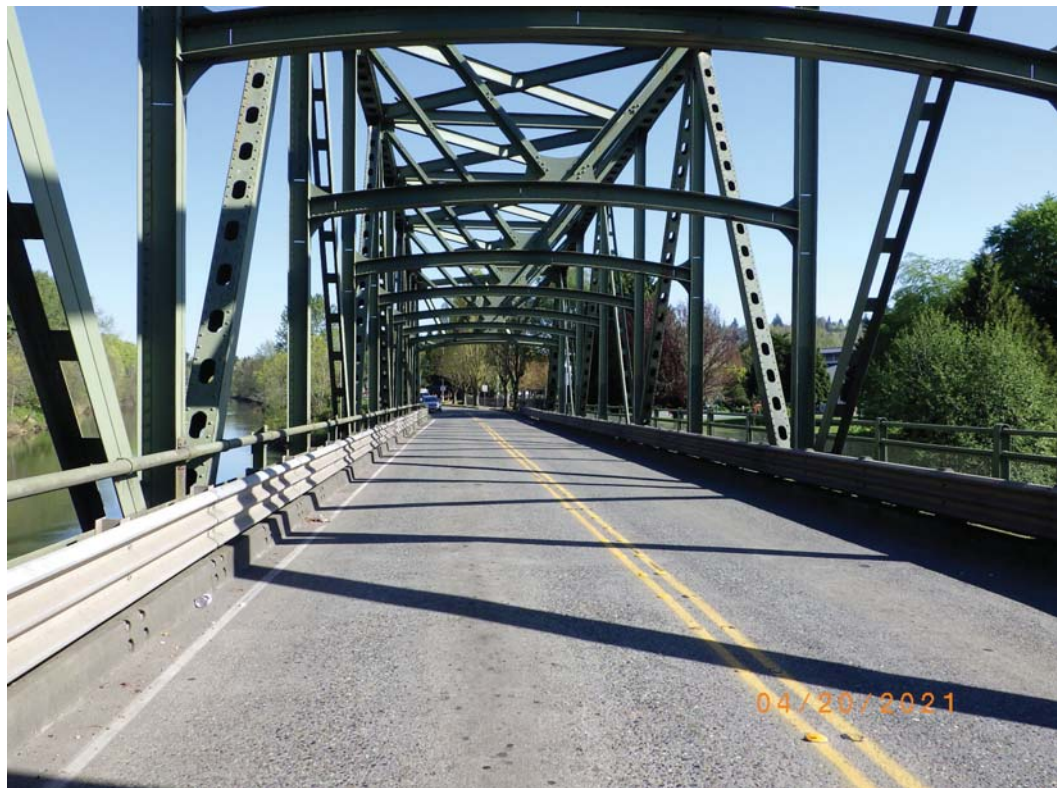
Photo Type: D - Deck  
Orientation: N  
Date: 4/20/2021  
Repairs: 13480  
Remarks: Typical Deck

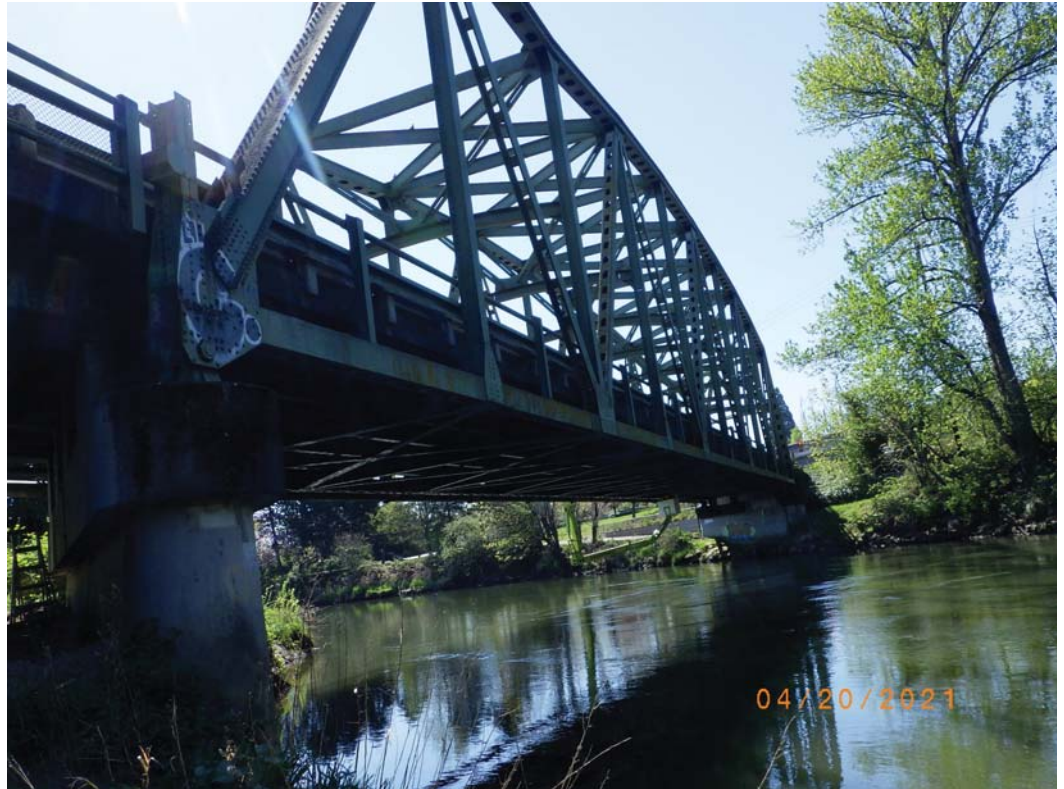
{root}  
Photo Type: G - General  
Orientation: E  
Date: 4/20/2021  
Repairs: 13471  
Remarks: Typical Superstructure

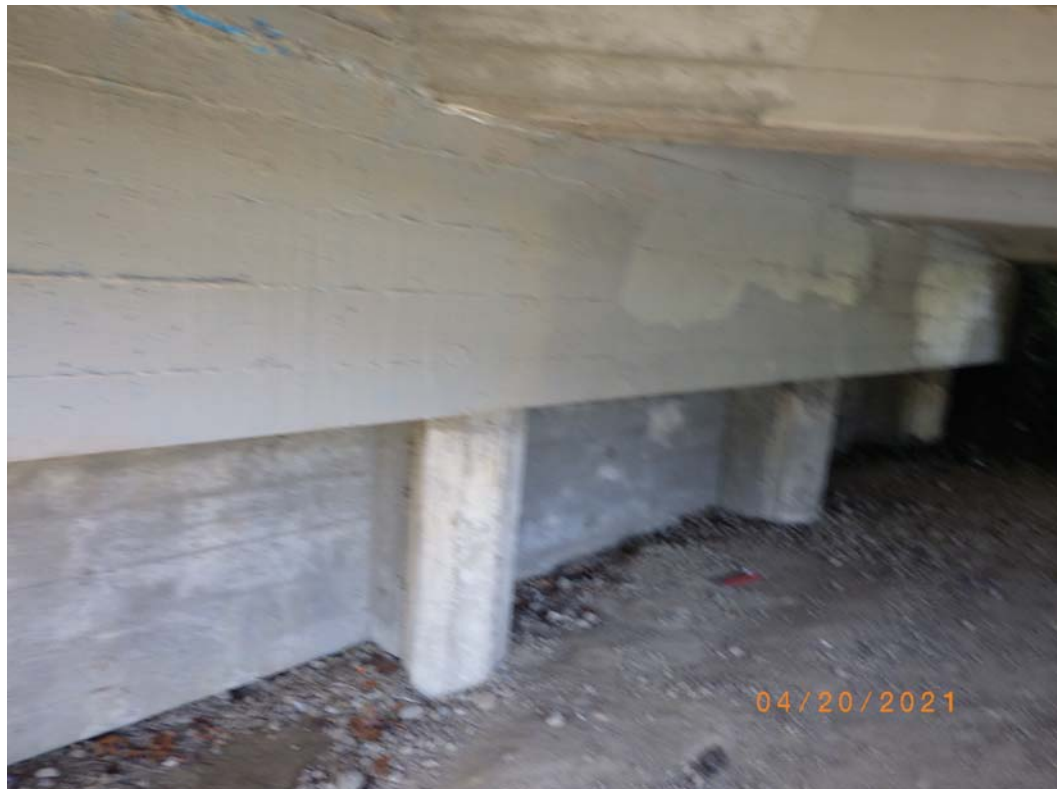
## HJ (48) - ABUTMENT 1

{root}  
Photo Type: G - General  
Orientation: S  
Date: 4/20/2021  
Repairs:  
Remarks: South Abutment

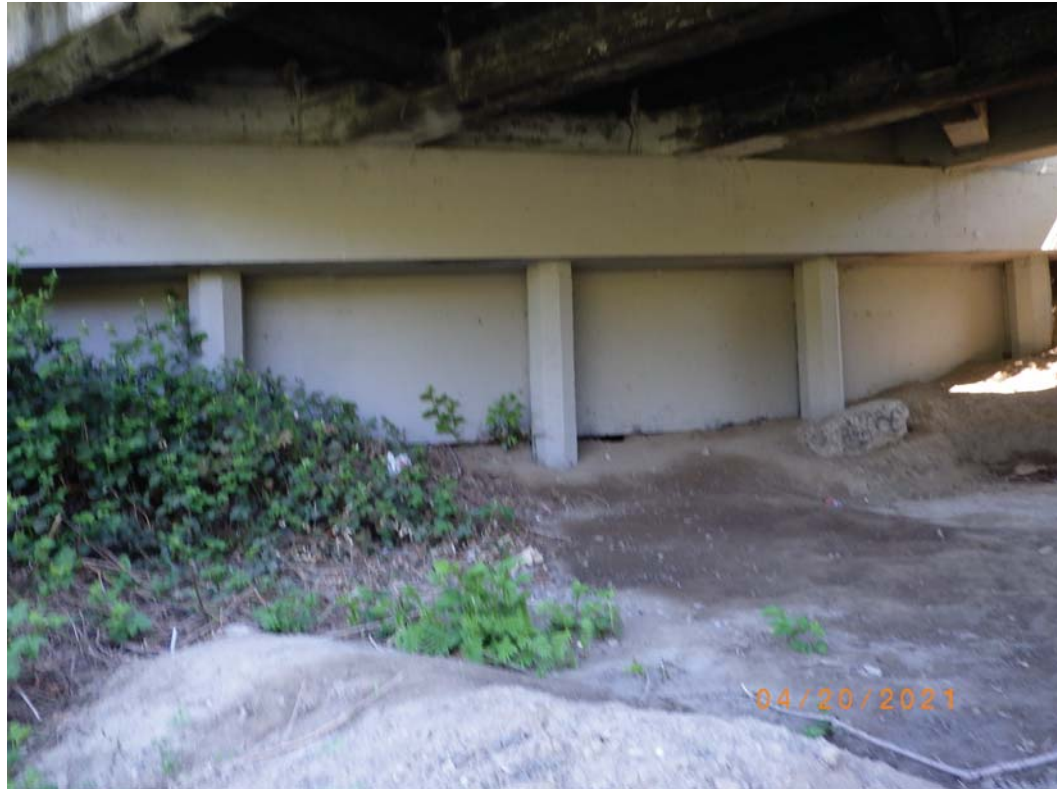
{root}  
Photo Type: G - General  
Orientation: N  
Date: 4/20/2021  
Repairs: 13475  
Remarks: North Abutment

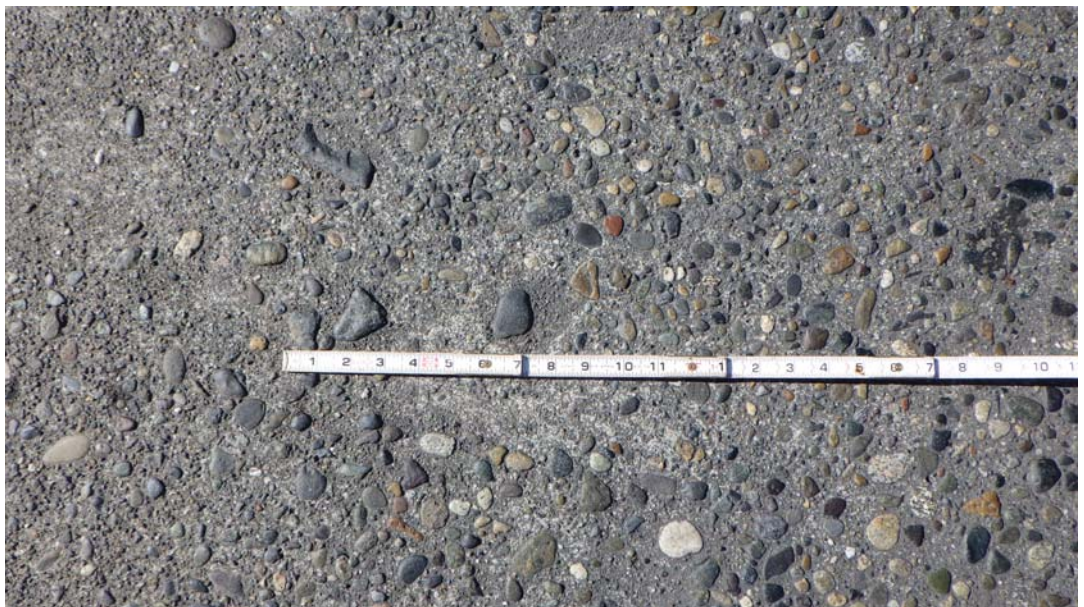
**2021\_MAG (5)**  
**DECK**  
**AGGREGATE**

{root}  
Photo Type: D - Deck  
Orientation: DN  
Date: 4/20/2021  
Repairs: 13480  
Remarks: Heavy Deck Scaling large

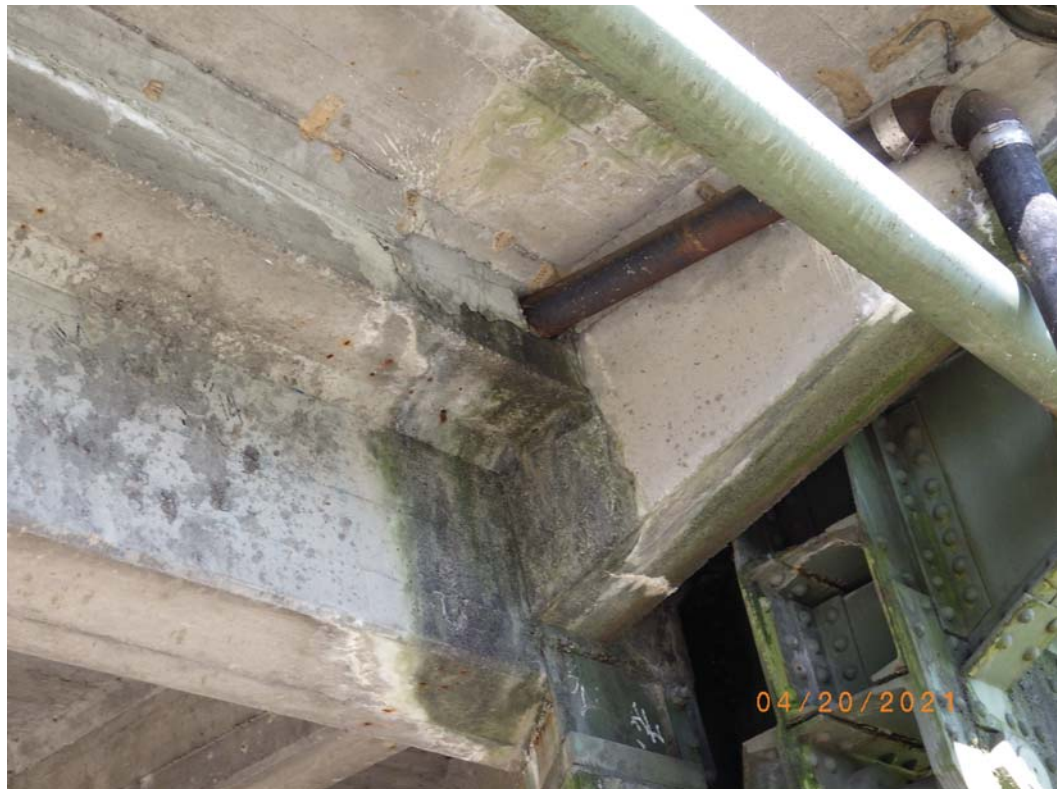
Remarks: Girder 1D - Delamination at  
Drainage Pipe Interface

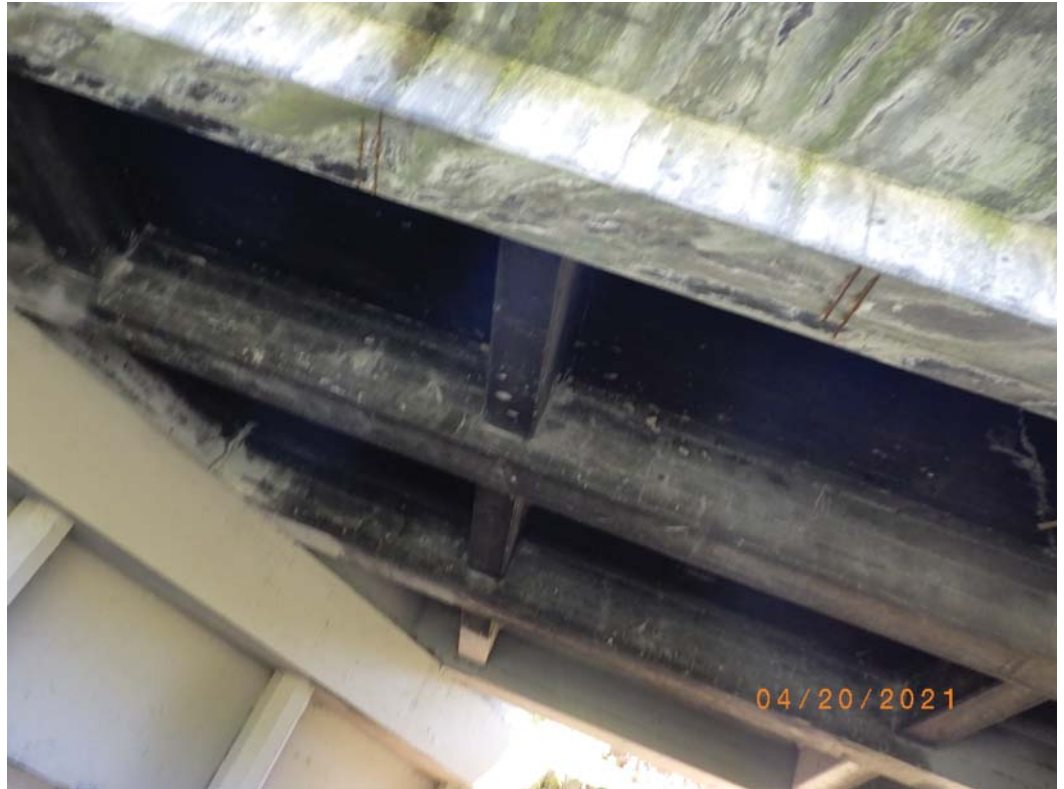
Remarks: Span 3 Girders - Soot Stained  
and Typical Exposed Rebar

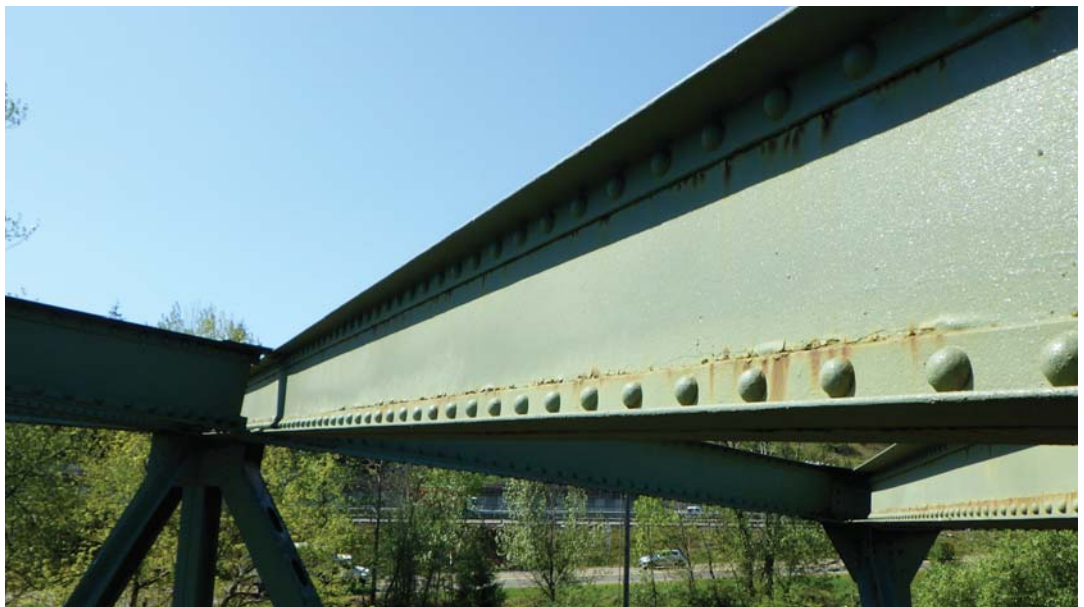
Remarks: Pack Rust between seams  
throughout Upper Chords

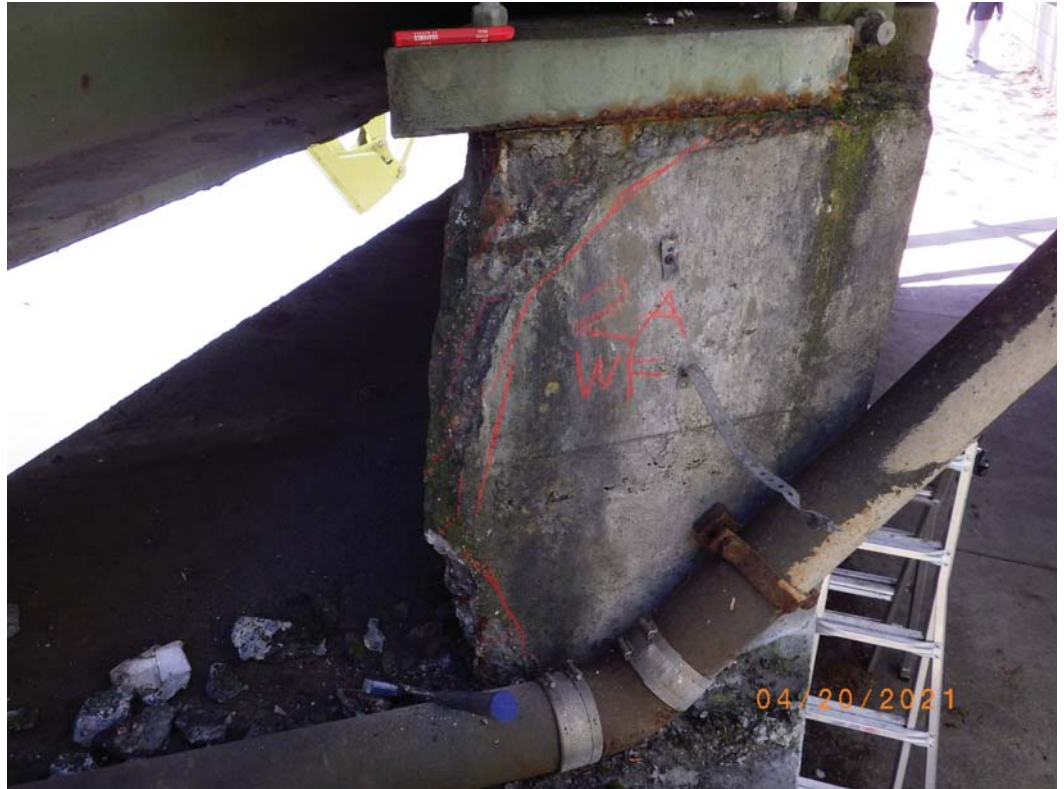
Remarks: Column 2A West Face - Full  
Height Spalling with Exposed Bearing  
Anchors

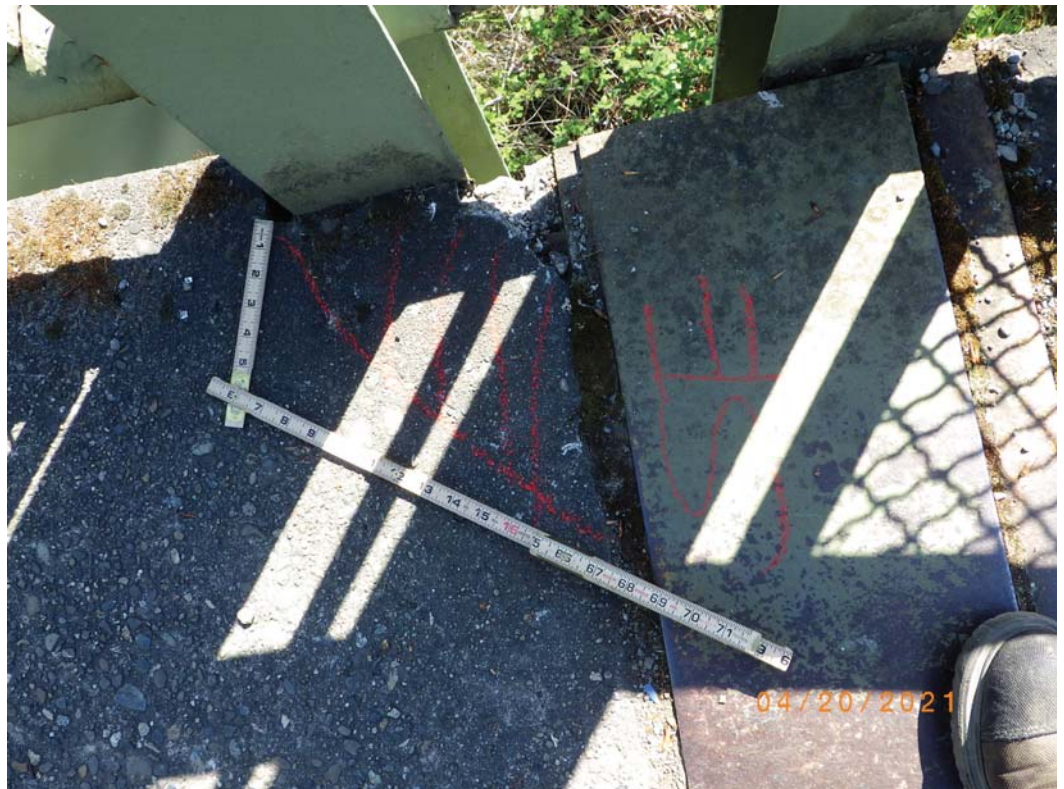
## HJ (85) - SE SIDEWALK DELAM

Remarks: Southeast Sidewalk  
Delamination

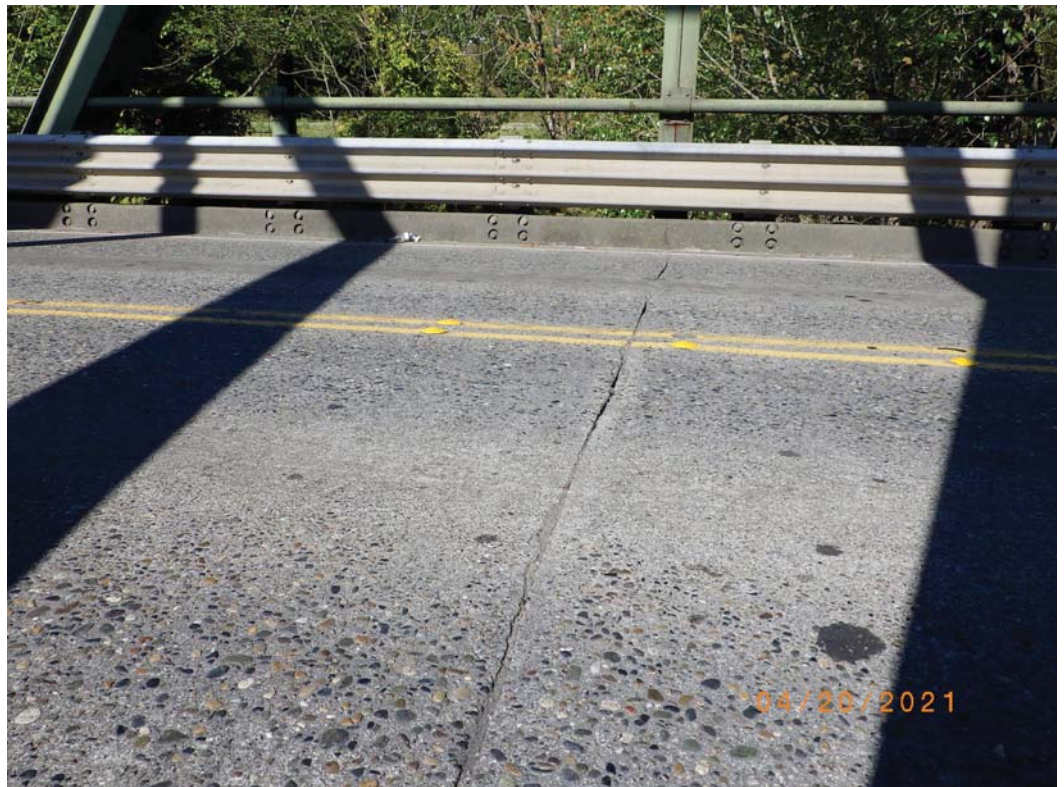
Remarks: Typical open joint Span 2 (Joint 3 shown)

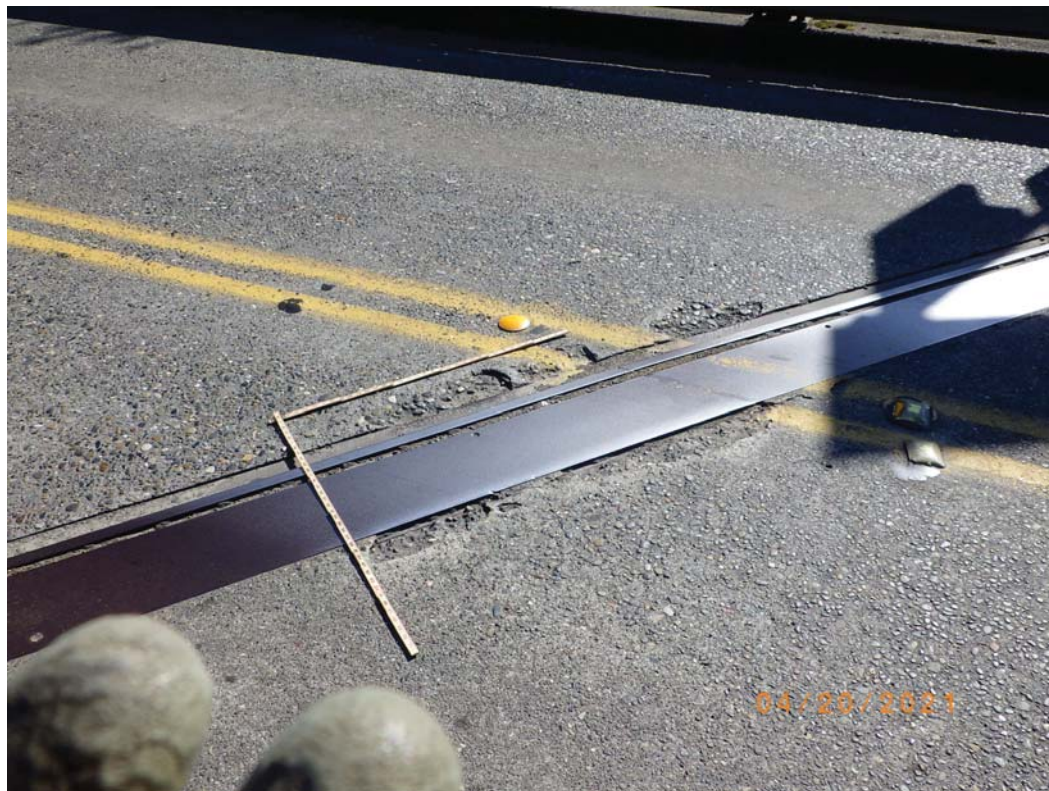
Remarks: Steel Sliding Plate Joint (South) at south end of truss

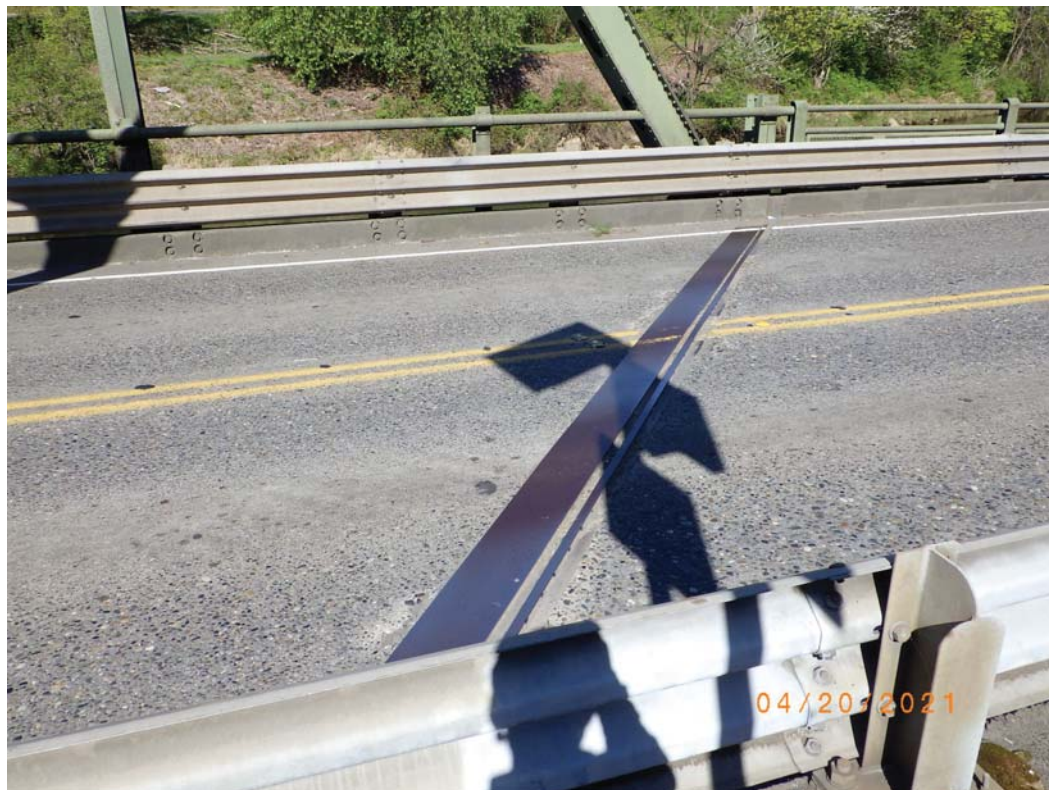
## HJ (37) JOINT 11 N

Remarks: Steel Sliding Plate Joint (North) at north end of truss

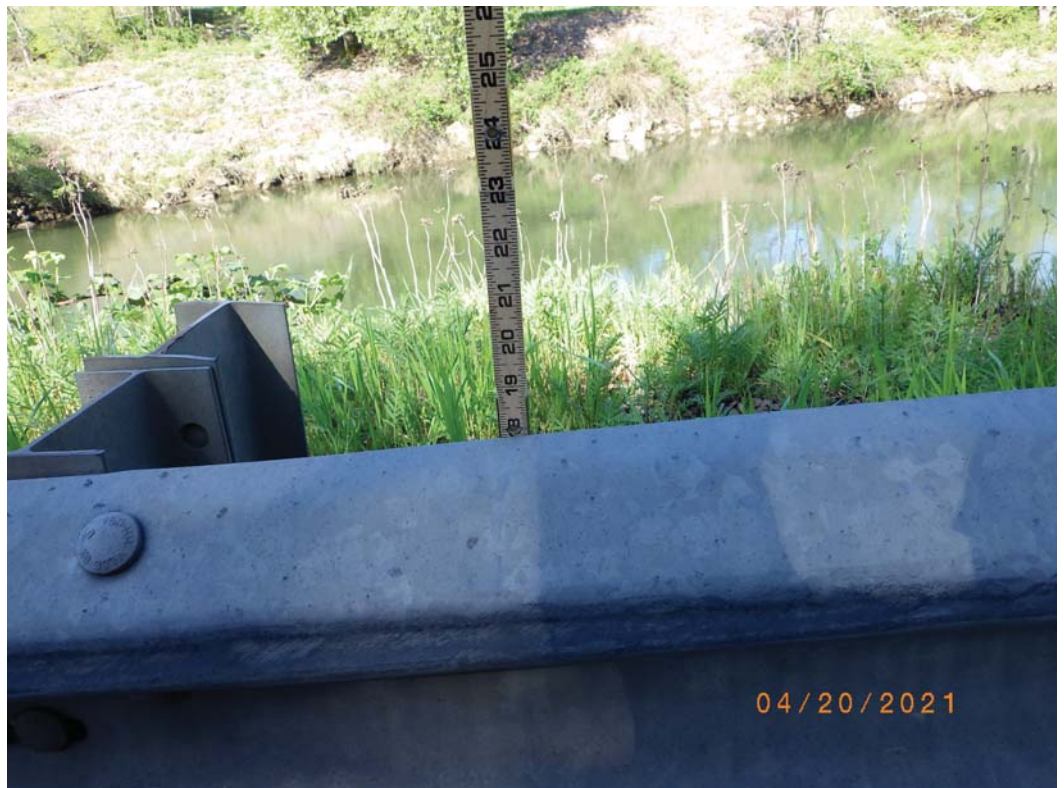
## HJ (42) RAIL HEIGHT

Remarks: North East Rail Height

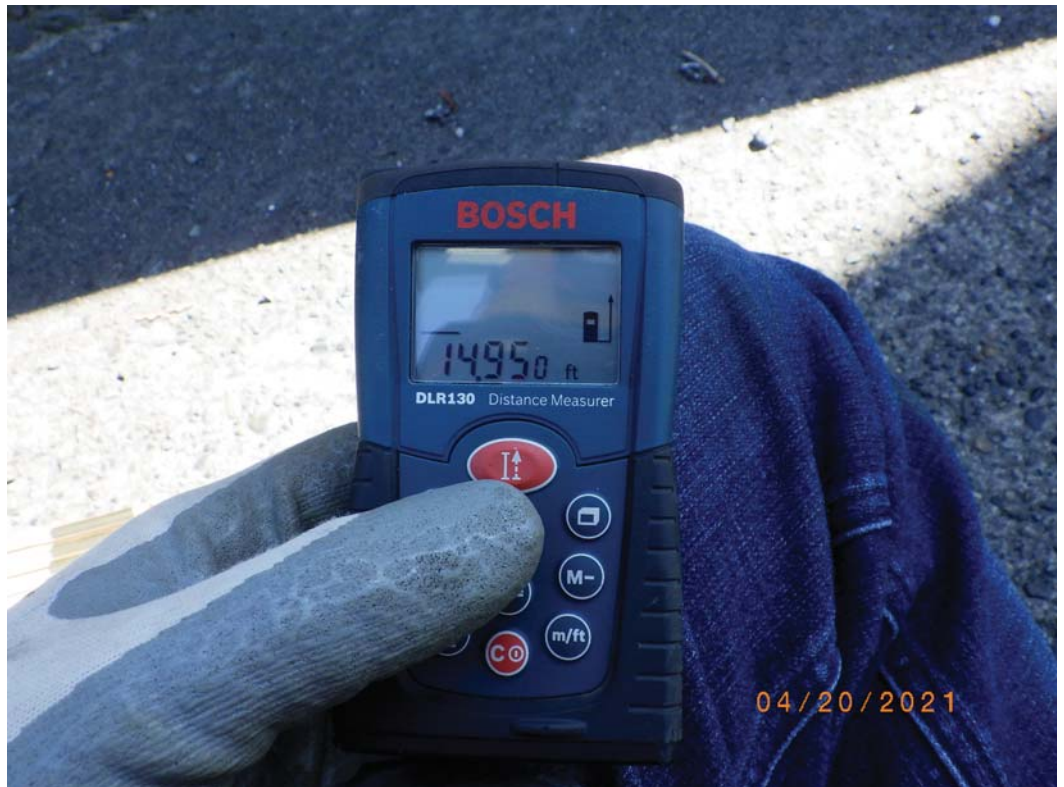
Photo Type: G - General  
Orientation: DN  
Date: 4/20/2021  
Repairs: 13478  
Remarks: Minimum Clearance  
Measurement (North Portal - East  
Fogline)

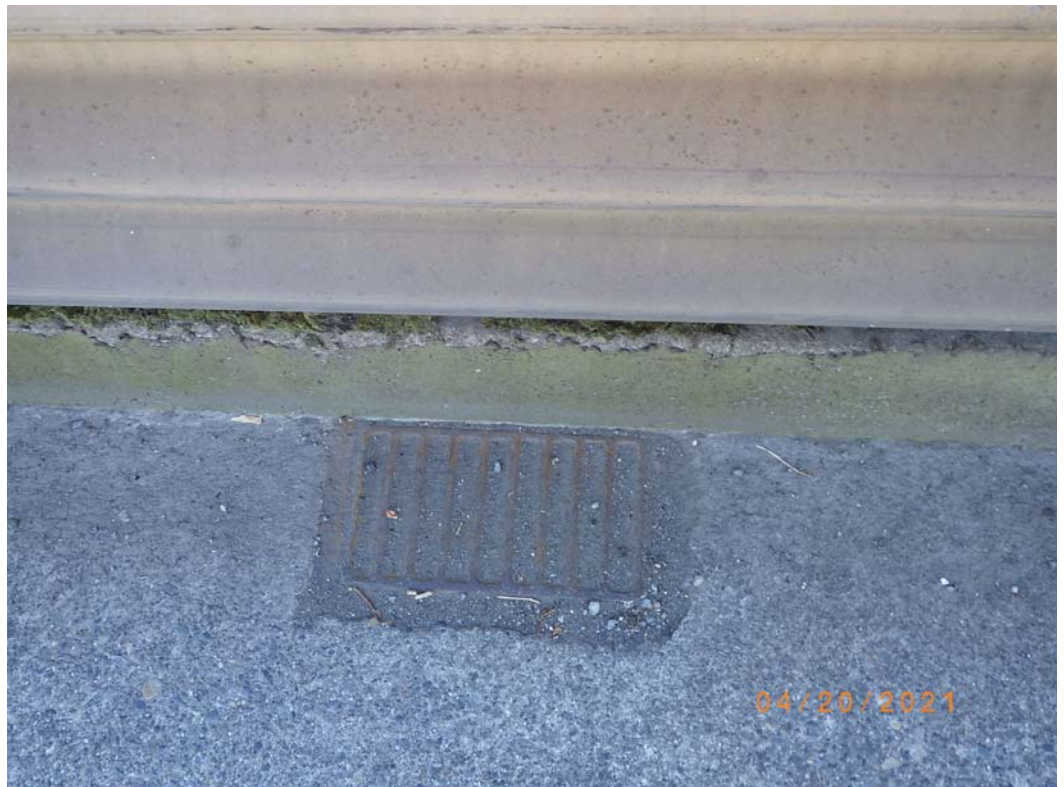
## HJ (29) PLUGGED DECK DRAIN

Remarks: Plugged Deck Drain

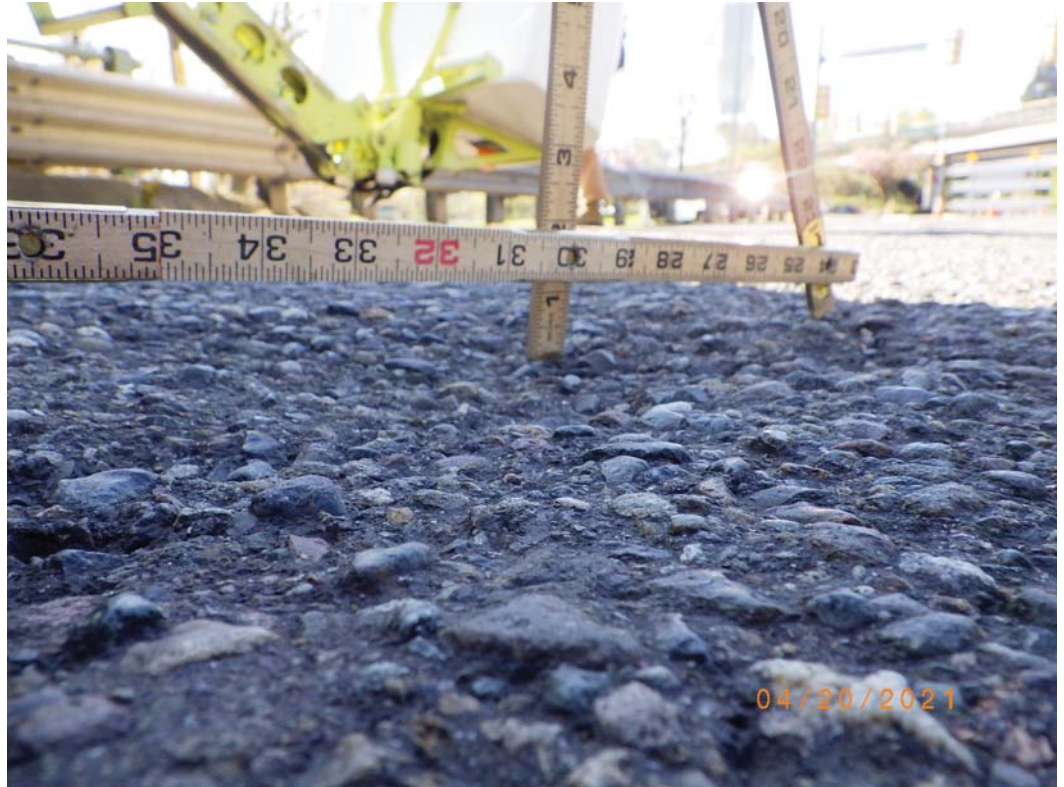
Remarks: South Approach Settlement

The City has been struggling with the deterioration of this bridge for many years. Starting in the 1990's with an expensive painting project, and followed a few years later by the emergency shoring of the northern approach roadway with a sheet pile wall system when the river threatened to wash away its northern approach fill. Even after those repairs, the north approach has continued to settle requiring constant maintenance to

provide a smooth transition onto the bridge. The existing steel truss is a Fracture Critical structure and requires costly special access inspections every 24 months which must be preceded by a cleaning of the structure to allow complete access to critical connections. Cleaning the bridge is also expensive and a logistical headache that yields only short-term benefits. The bridge currently needs further maintenance, and the cost of the necessary

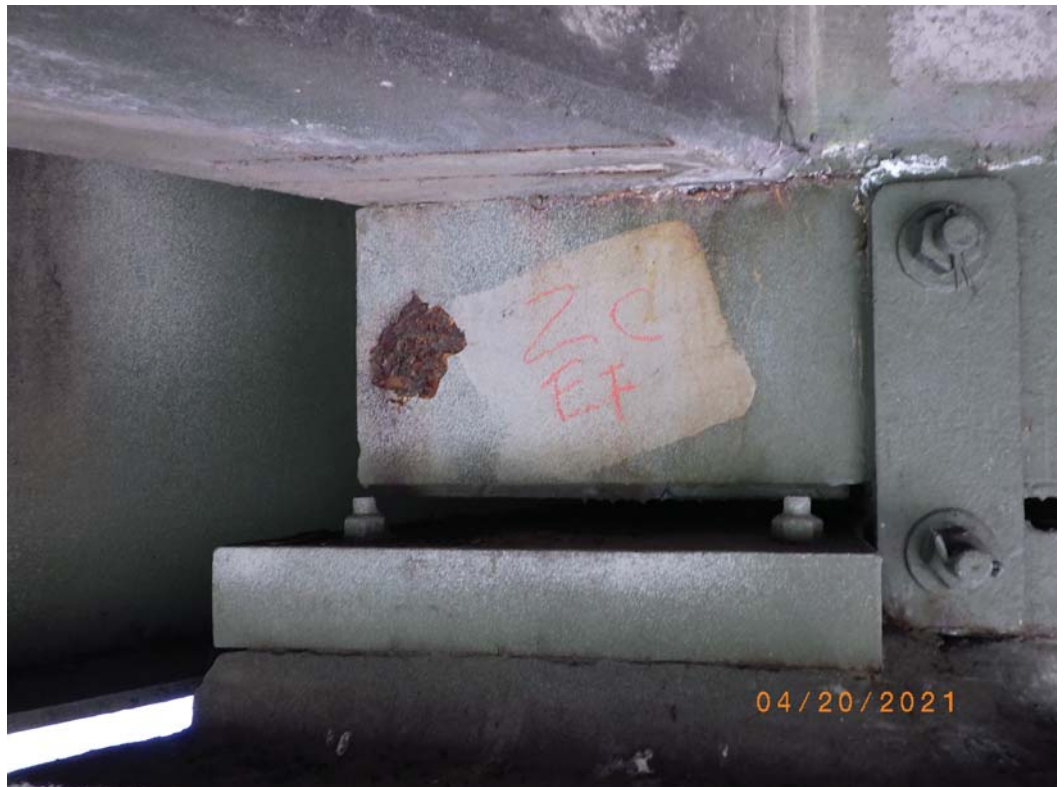
## HJ (105) BEARING 3C

Remarks: Approach Bearing (Bearing 3C Depicted)

The bridge bearings are locked causing continuing damage from temperature related expansion and contraction of the bridge. These deficiencies coupled with the bridge geometry have resulted in a bridge at risk of collapse during a strong seismic event.

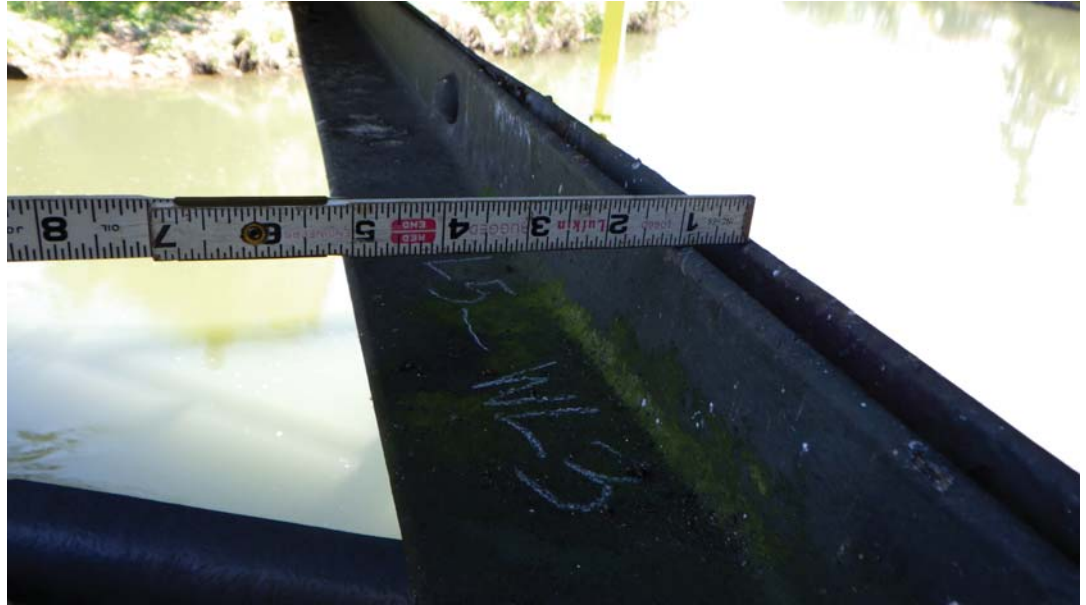
Photo Type: G - General  
Orientation: NE  
Date: 4/20/2021  
Repairs:  
Remarks: Pack rust between angles  
deforming bracing.

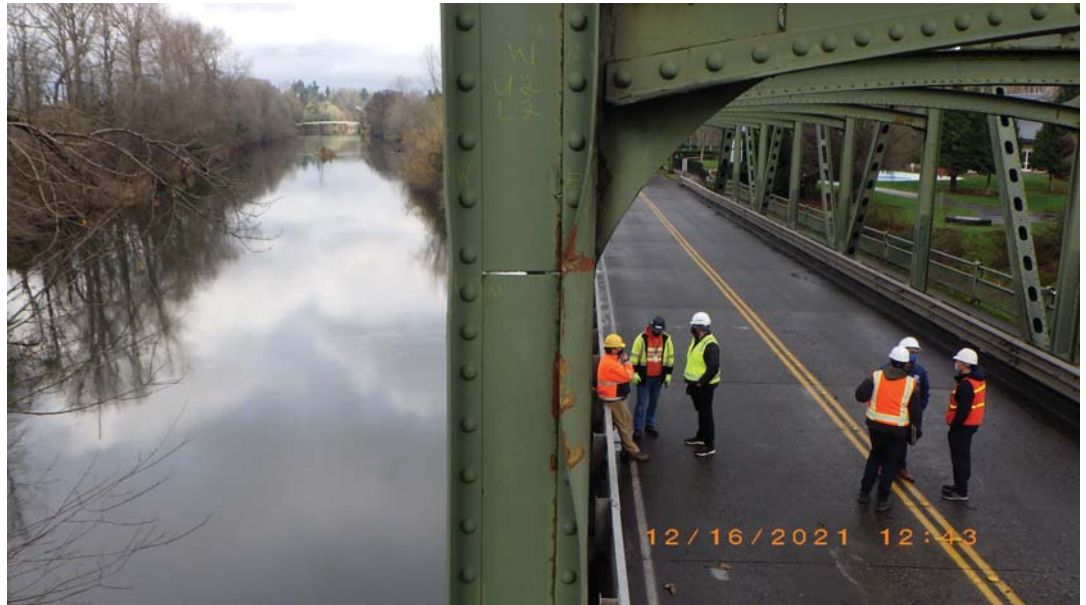
REMARKS: Bent flange from load impact  
near lateral vertical connection

On December 15, 2021, the bridge was subject to a high impact load from a truck. The truck struck one sway frame of the bridge and inflicted some critical damages to it and its associated vertical elements of the through-trusses of the bridge. The City staff quickly got involved in securing a contractor for the repair of the damaged elements of the bridge. The bridge damages were repaired via a straightening process and the repairs were completed on January 3<sup>rd</sup>, 2022.

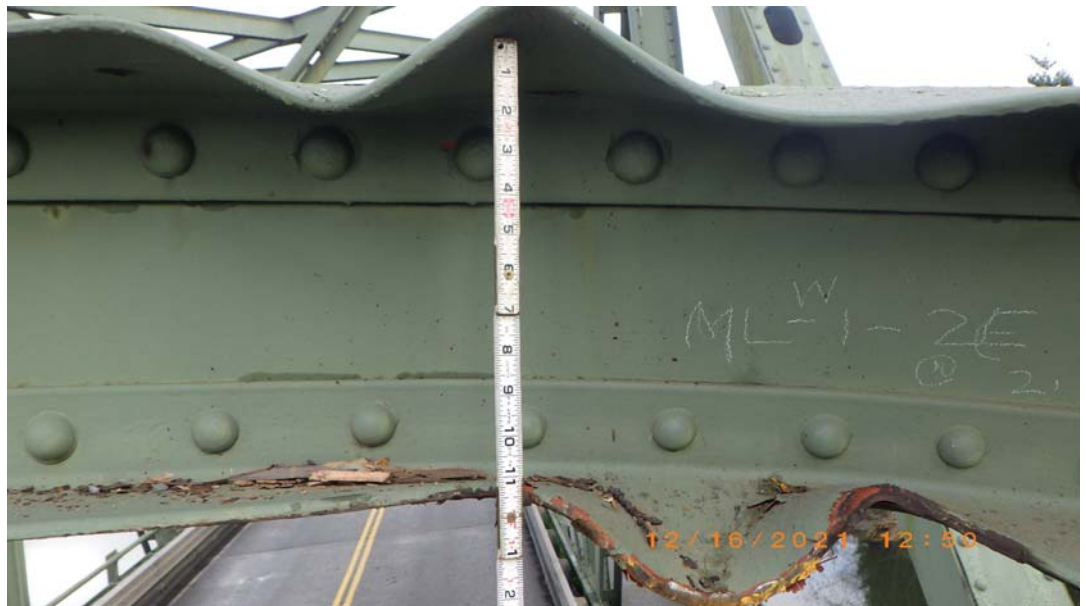
## M-LATERAL SE FACE

Damaged sway brace frame

REMARKS: Flange damage at impact  
point of mid level lateral brace.
