Facility Evaluation Criteria

Facility Assessments

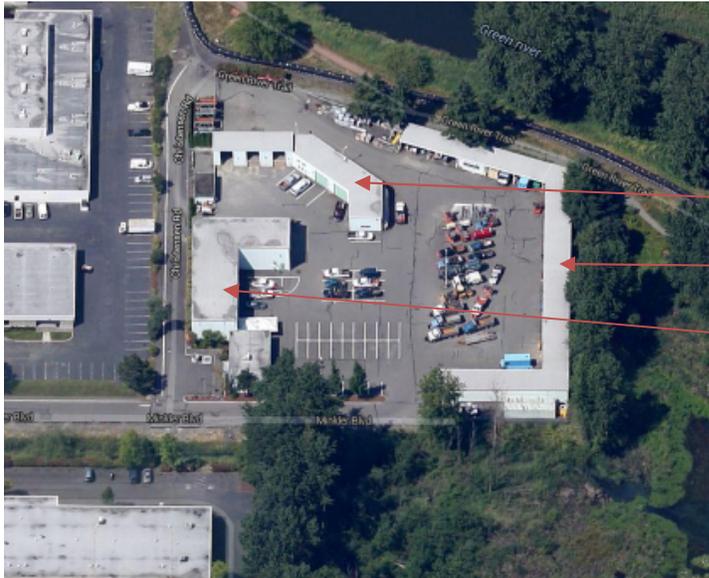
Acoustics: *Score -1*

In general, there does not appear to be any significant acoustical issues at the facility. Staff did note that the large crew room also serves as a meeting room and that there are some echo-related acoustical issues due to the hard floor, wall, and ceiling surfaces that make the room somewhat noisy when heavily occupied.

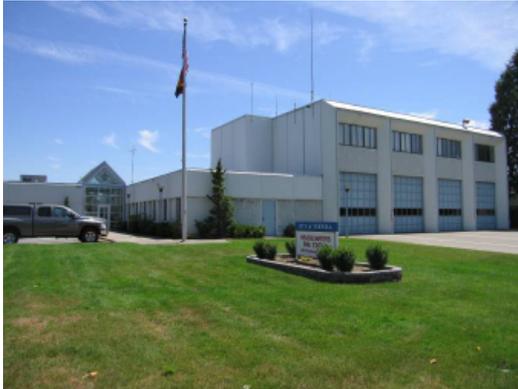
Acoustics *Score 0*

No acoustic issues were noted.

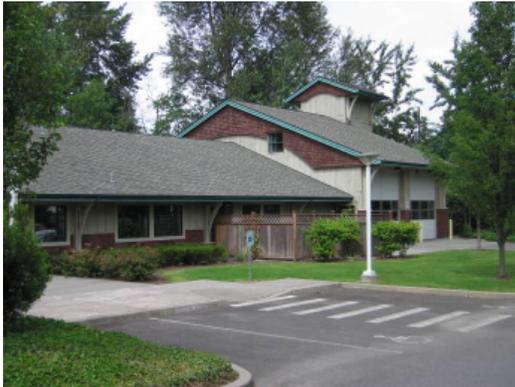
Acoustics *Score -1*

The station utilizes residential-grade, window-mounted air conditioners at the sleep rooms and day room. As such, they allow road noise from the street side of the building to transmit easily into the crew sleeping portions of the building.

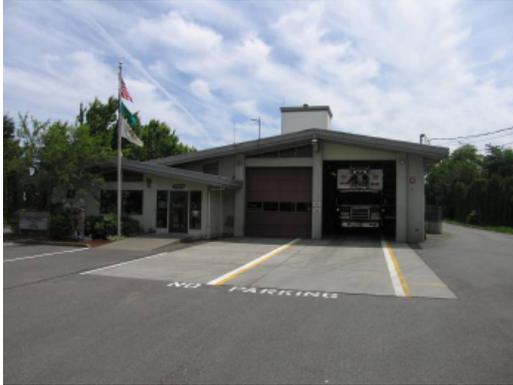
Acoustics *Score 0*

No acoustic issues or problems have been identified.
